FINDING RETROFITS – ROADWAY DISCONNECTION CASE STUDIES

CLEAR December Disconnection Workshop Series
December 9, 2020

Roadway Disconnections in East Lyme

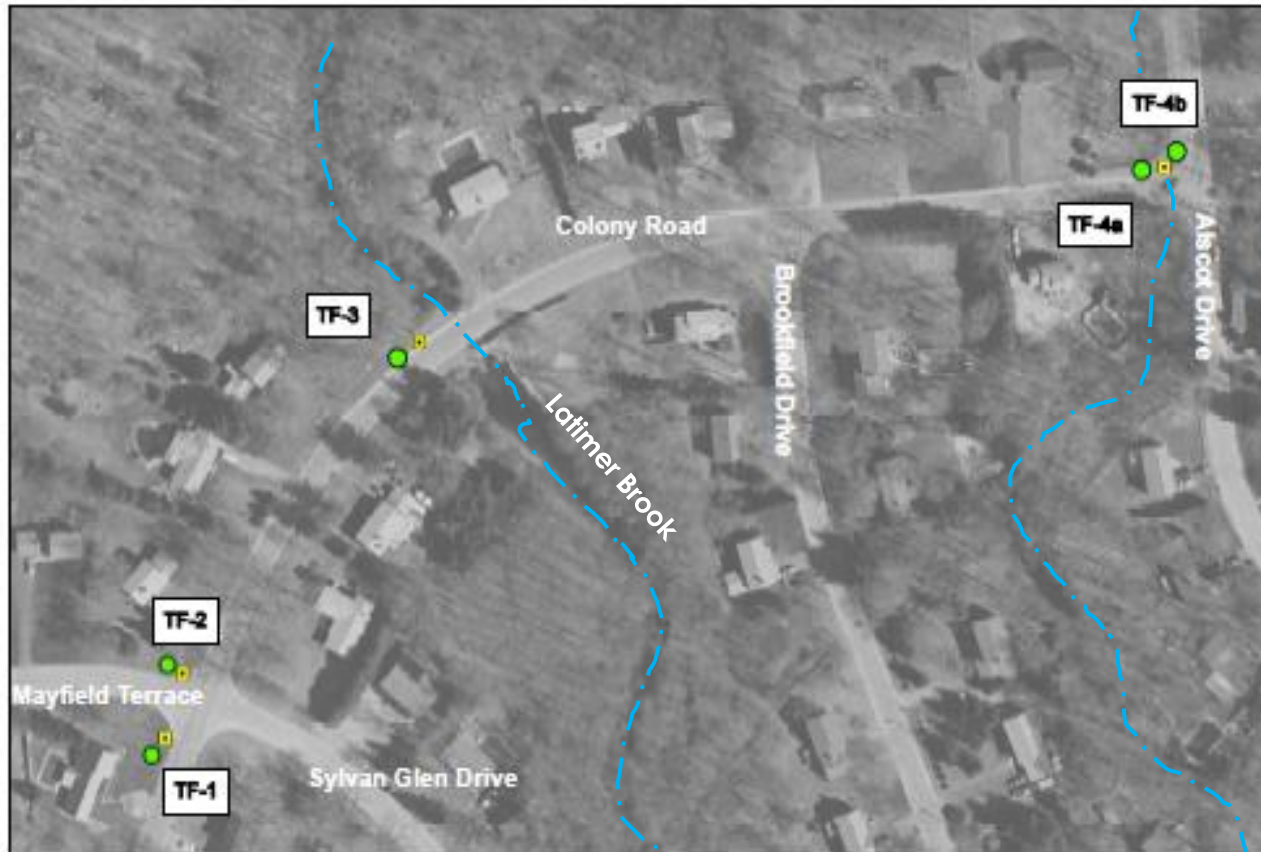
Tree Filter Locations - Colony Road, East Lyme, CT

Tree Filter	Disconnected Area (acres)
TF-1	0.35
TF-2	0.35
TF-3	0.25
TF-4a & 4b	0.25
Total	1.2 acres

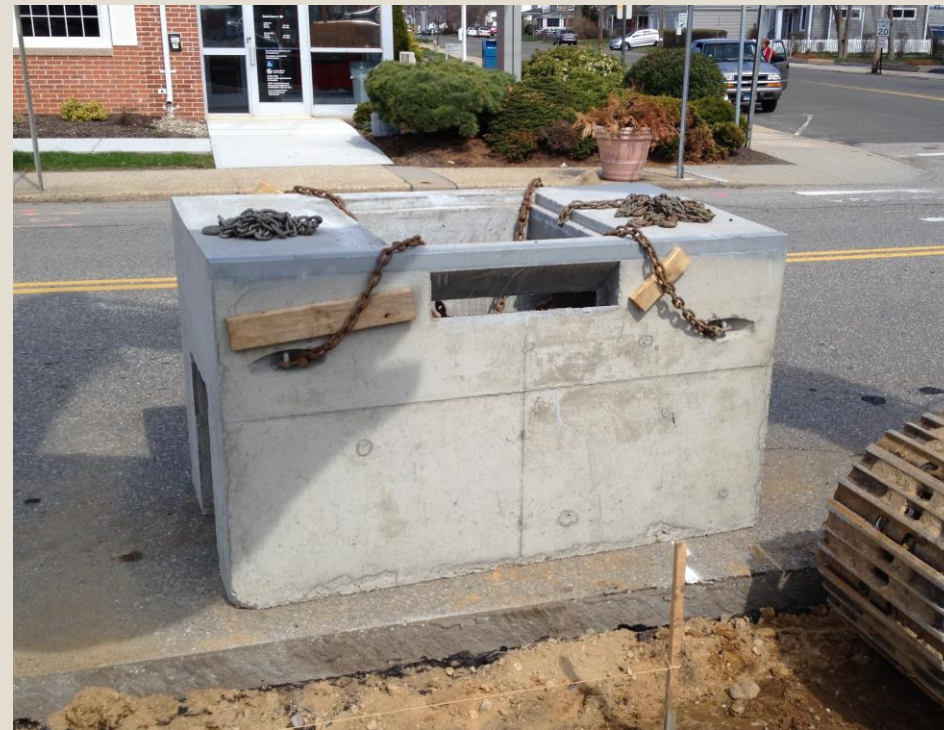
- The tree filter design was altered to take advantage of site conditions
- The presence of deep stratified drift deposits below the site allowed us to decouple the tree filters from the stormdrain system
- This gave us greater flexibility in siting the tree filters
- Leveraging our funding sources allowed us to maximize the effectiveness of the BMP

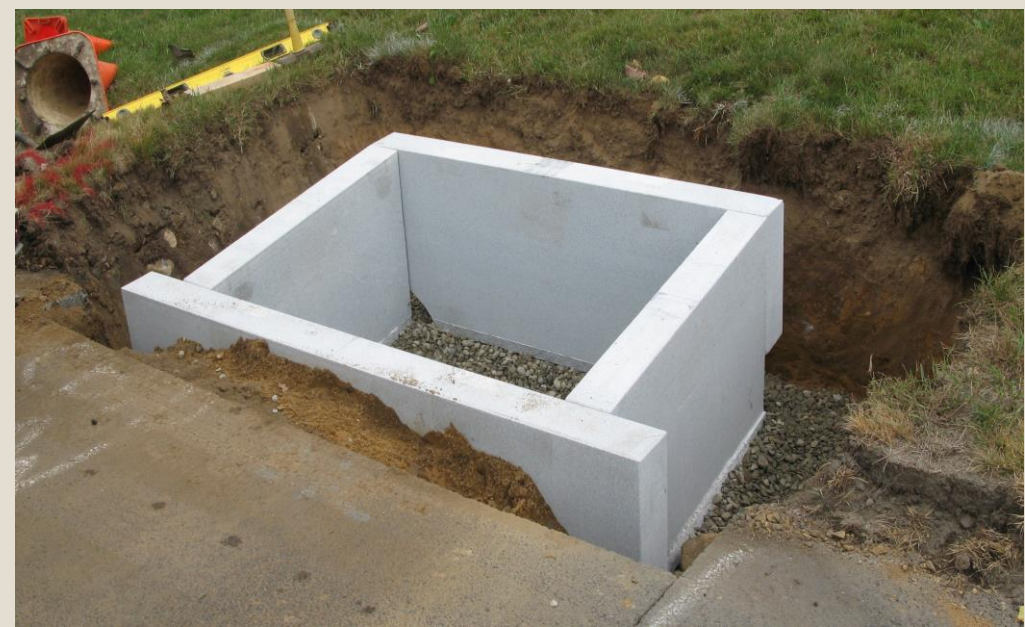
What is a Tree Well?

- East Lyme planning major repaving project in 80-acre mixed commercial and residential neighborhood adjacent to Niantic River. Contacted ECCD to see if we could install more tree filters.
- ECCD obtained CWA §319 funding.
- East Lyme engineering staff developed an alternative design which was 1/3 the cost of a precast tree filter
